Report
On
The Trial Installation
Of
Central Products, STAC System
To
Pipe and Flange of Valve
At

Block 19A - Berth 13

**Port of Tanjung Pelepas**

March 2015

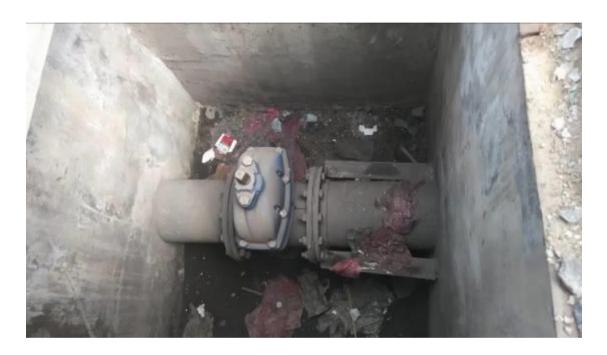
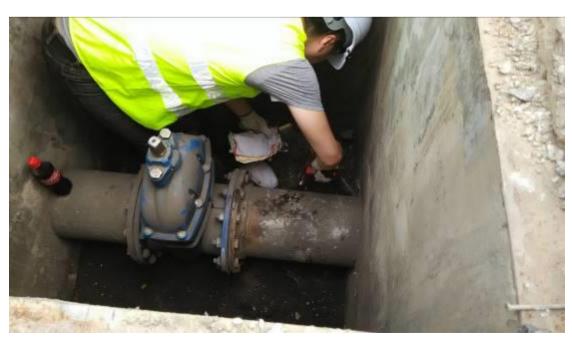
The valve and flange is observed to be in good conditions with no signs of corrosion.

The flange mounted DI pipe shows sign of rust at the welded areas. The coating is flaking up and surface is dried up without protection.
