JETI PELURU, TLDM, LUMUT, PERAK, MALAYSIA -
(Armory jetty, Royal Malaysian Navy, Lumut, Perak, Malaysia)

REPORT ON CONDITION OF SPLASHPRO M1-80 SYSTEM BASED ON SITE INSPECTION

- Client** : TLDM (Royal Malaysian Navy), Lumut, Perak /
JKR, Cawangan Pangkalan Udara Dan Maritim
- Contractor** : Akid Merah Sdn Bhd /
CLM Construction & Trading Sdn Bhd
- Description** : The jetty comprises 105 steel piles.
There are 30 nos. 480mm diameter and 75 nos. 630mm diameter
The splash zone height is 4000mm. Total protected area is 724 sq.m
- Installation** : February to March 2007
- Material used** : SPLASHpro M1-80 System comprising
STACprime UW, STACfill, STACwrap (150mm & 300mm),
STACguard, SS317L band (12.5mm / 0.76 mm), SS 316 Buckle
- Manufactured by** : Central Products LLC, USA /CP Coatings Sdn Bhd
- Supplied through** : STAC System Sdn Bhd
- Inspection Date** : 6th March 2015

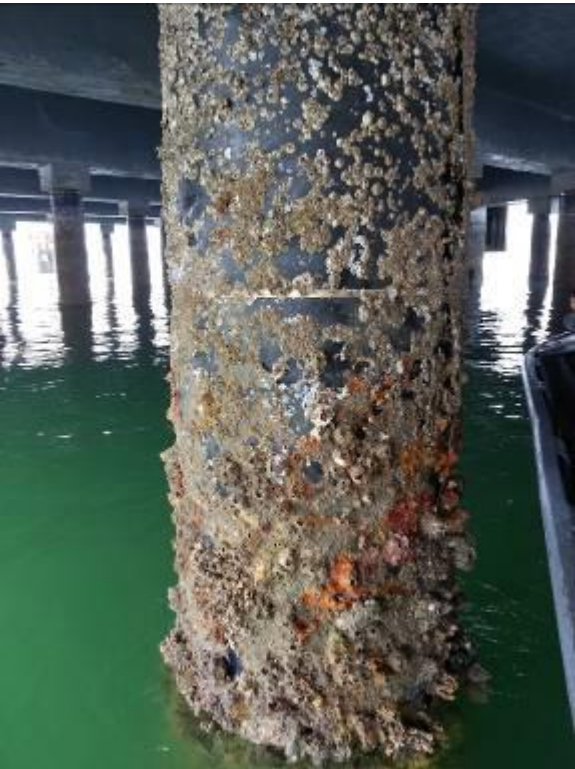
Photo 9: View of SS 317L Bands

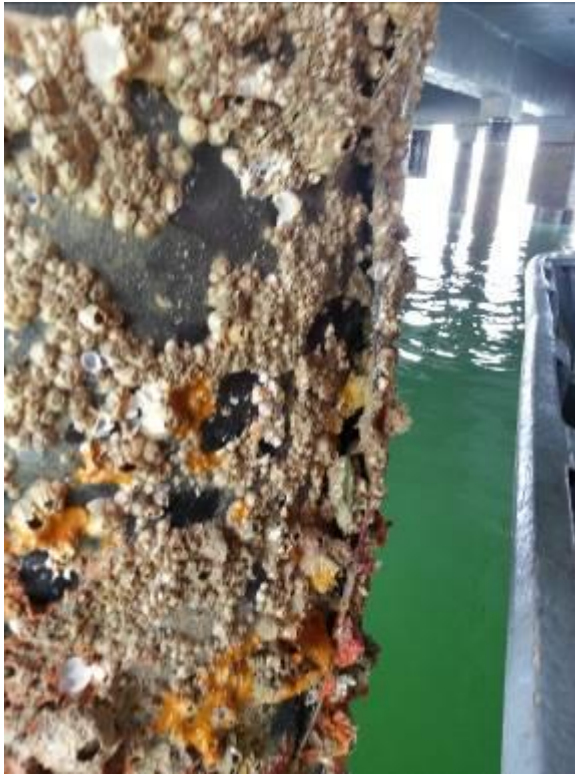
Photo 13: View of Barnacle Growth

1. All the jackets installed on the piles were intact and are in their original positions with none detected slipping down.
2. There was no detection of jackets missing from the piles.
3. There were no visible signs of injury or damage to the jackets.
4. All the straps were seen to be intact and holding up well. Some were observed with stains and some were still shiny.
5. There were visible signs of staining on the straps.
6. There was extensive growth of barnacles on the jackets and into the gaps of the overlap.

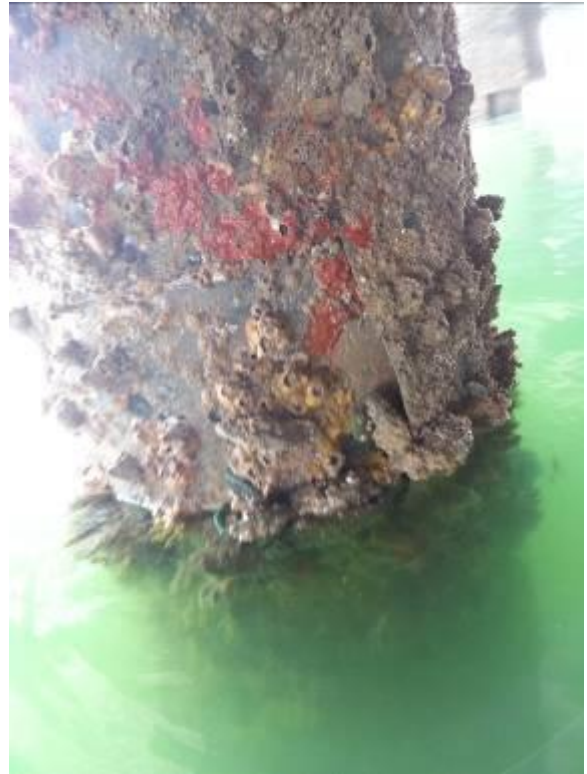
Photo 14: View of Barnacle Growth

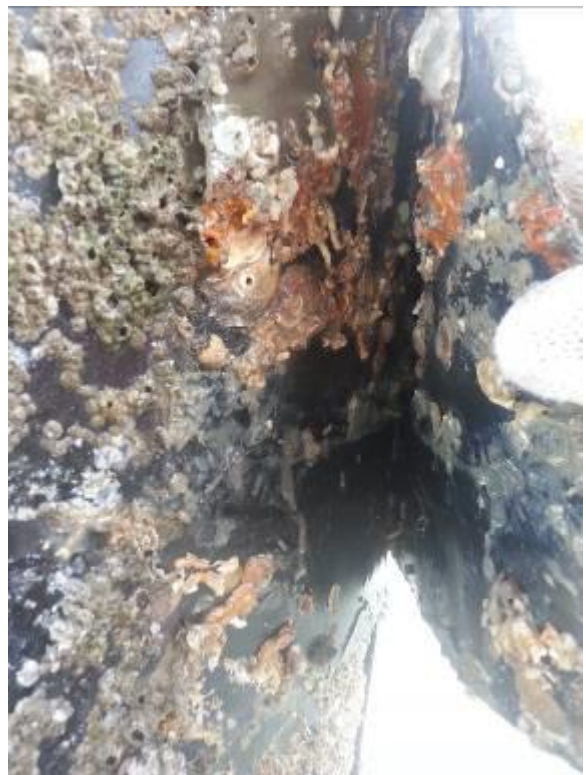
Photo 22: Growth into the Overlap

1. The barnacles could be removed with hand tools. There was no penetration of the barnacle into the HDPE jacket.
2. The barnacles grew into the overlap of the HDPE sheet, but not beyond the overlap.
3. Mud and water were found into the overlap and onto the STACwrap. Mud was observed on the STACwrap.
4. The STACwrap was seen to be in very original condition and no drying up was evident.

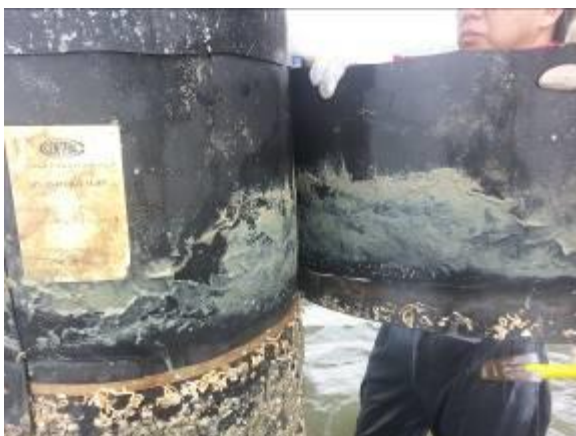
Photo 23: Ingress of Mud into Overlap

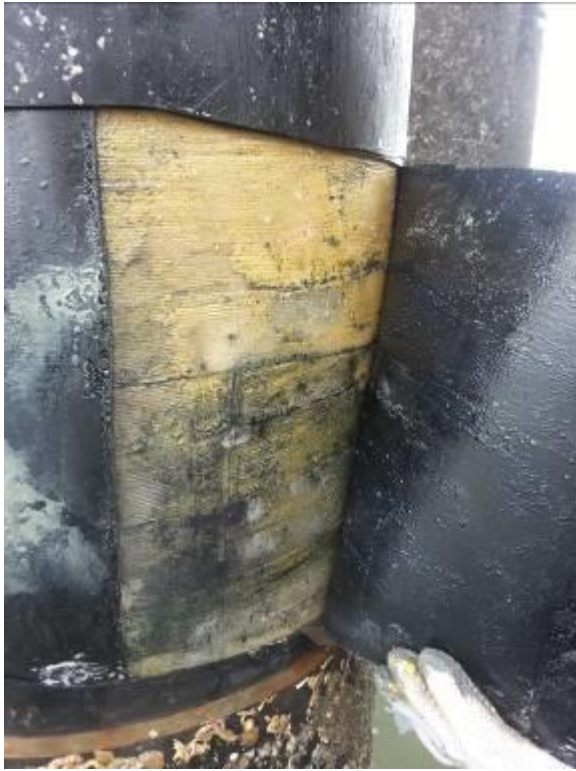
Photo 25: Ingress of Mud into STACwrap

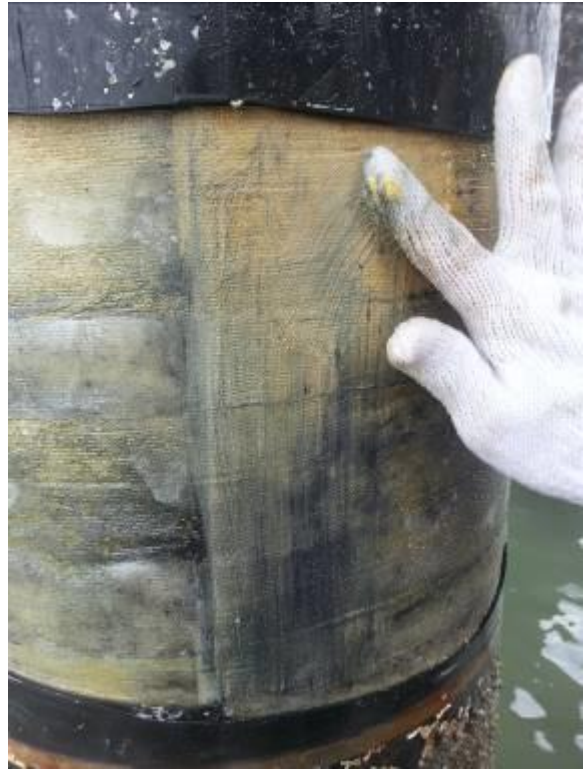
Photo 26: Condition of STACwrap

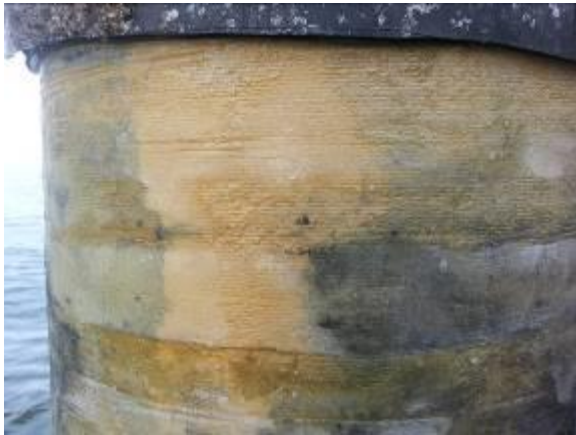
Photo 27: Condition of STACwrap

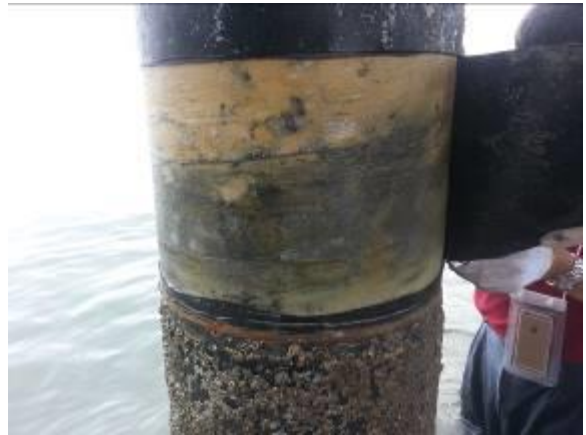
Photo 28: Condition of STACwrap

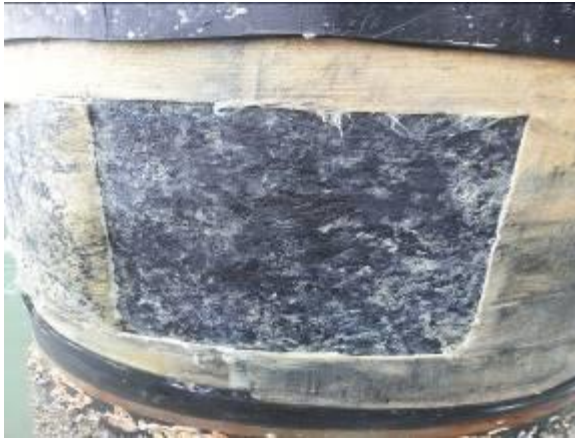
Photo 31: Condition of Steel Pile Surface

1. The HDPE Jacket is holding up well. No visible damage to the jackets were observed.
2. The bands and buckles are performing well. No jackets were seen slipping down. The bands and buckle had held the jackets in position firmly against the waves and other elements.
3. The STACwrap is performing well. It was observed that the STACwrap was still greasy and similar to the new STACwrap although made dirty by the mud.
4. The metal surface of the steel pile (from the sample inspected) appeared to be still coating in the petrolatum primer and the surface did not have evidence of further corrosion.

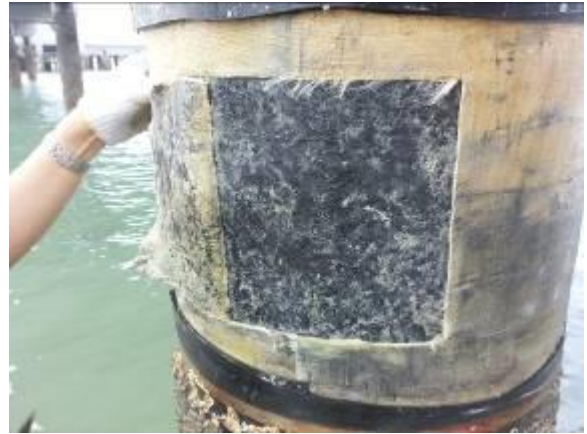
Photo 32: Condition of Steel Pile Surface

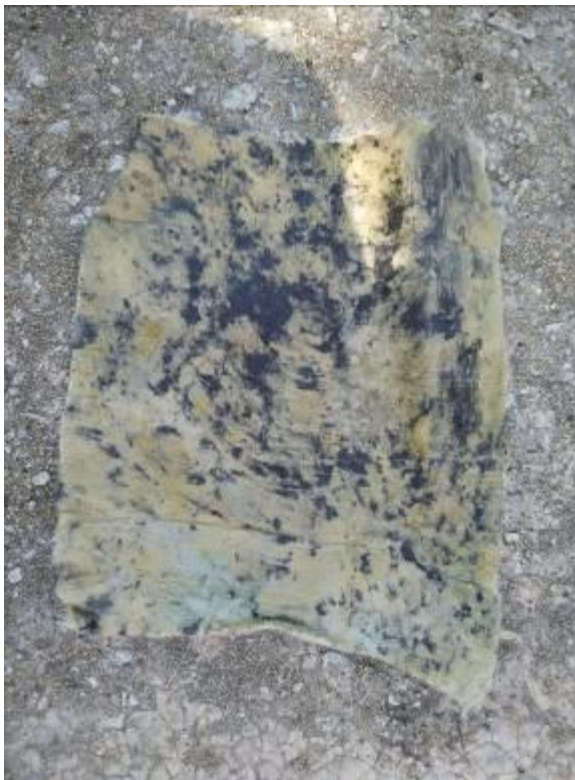
Photo 33: Condition of STACwrap

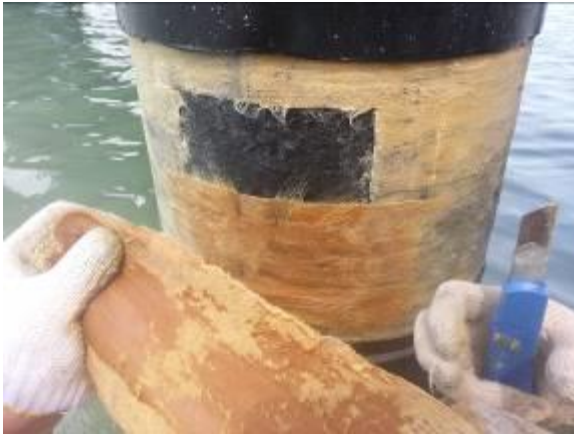
Photo 34: Patch with STACwrap

1. After completion of the inspection, the STACwrap of the removed section is replaced by a layer of STACwrap.
2. Thereafter, a new 2 layers of STACwrap is applied on over the entire removed jacket area.
3. A section of 500mm height of jacket is installed over the cut section with 2 straps of SS317L installed on the top and bottom edge.

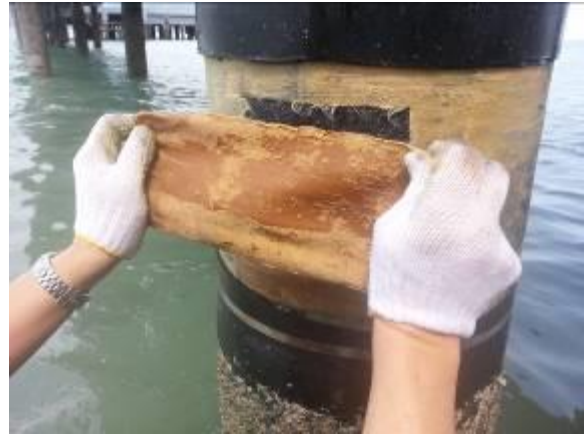
Photo 35: Patch with STACwrap

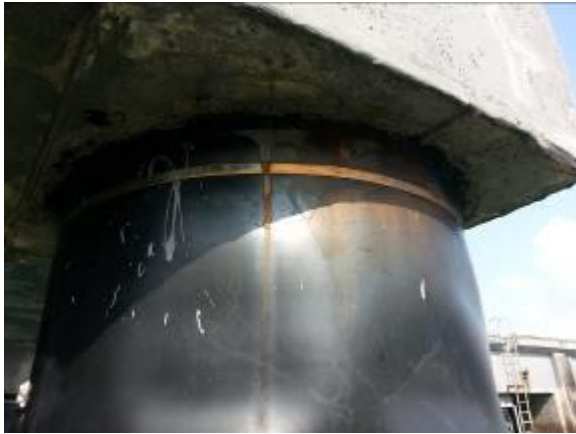
1. The SS317L bands were seen to have stains.
2. Hand brush was used to brush of the stains as well as the barnacle growth.
3. It is observed that these were sticking to the surface as the bands were still shining after cleaning.

Photo 47: Stained band

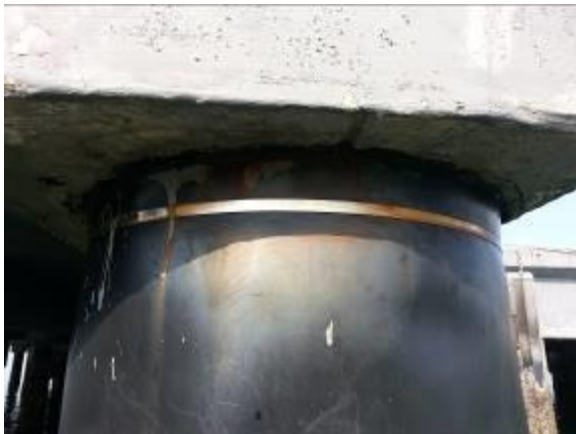
Photo 47: Shining surface of band

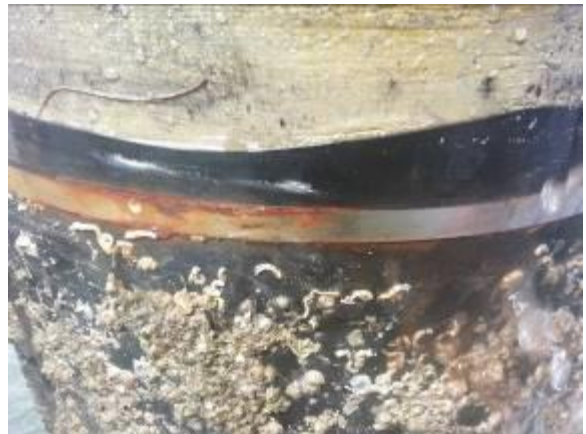
Photo 48: Stained Band

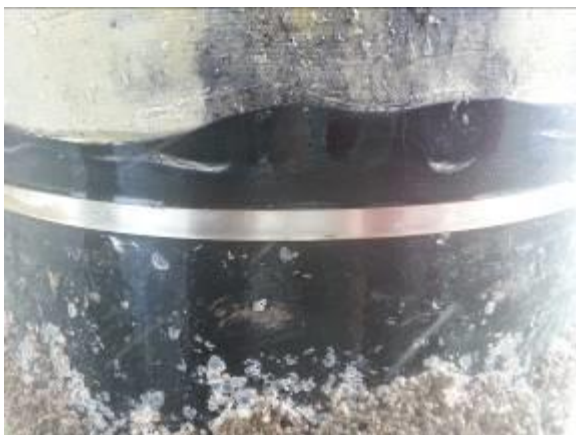
Photo 49: Shining surface of band

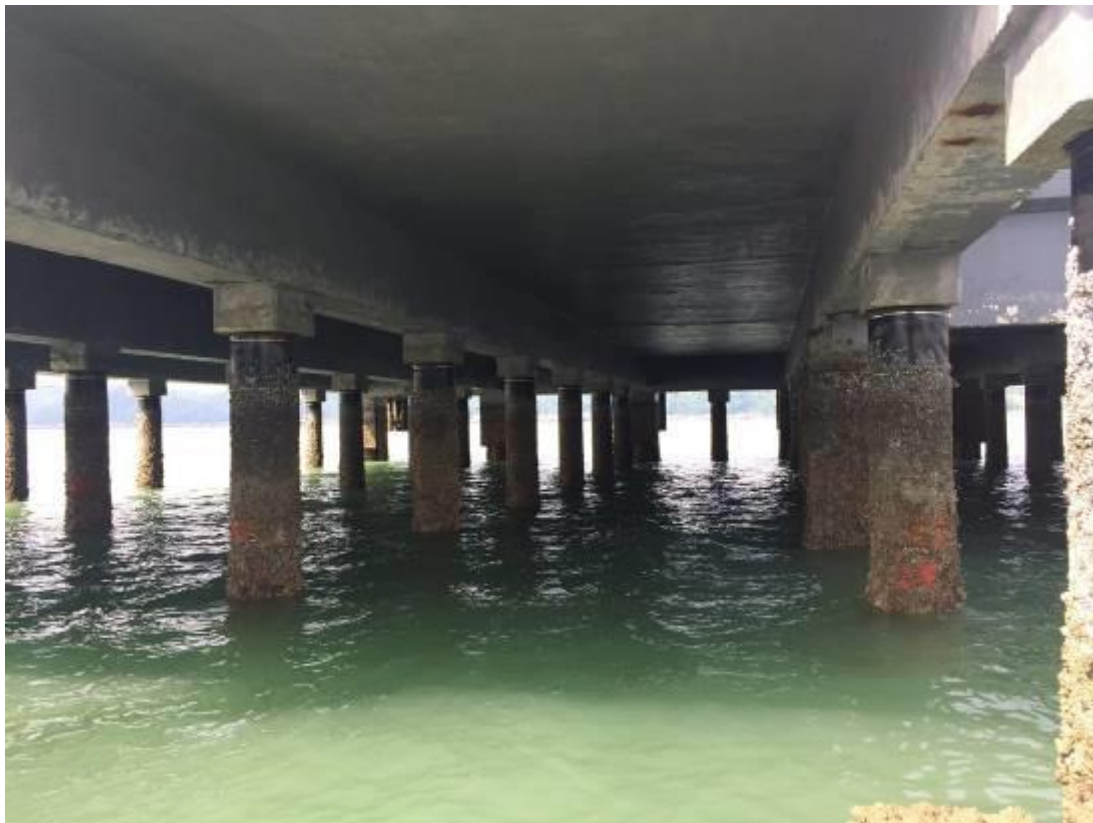
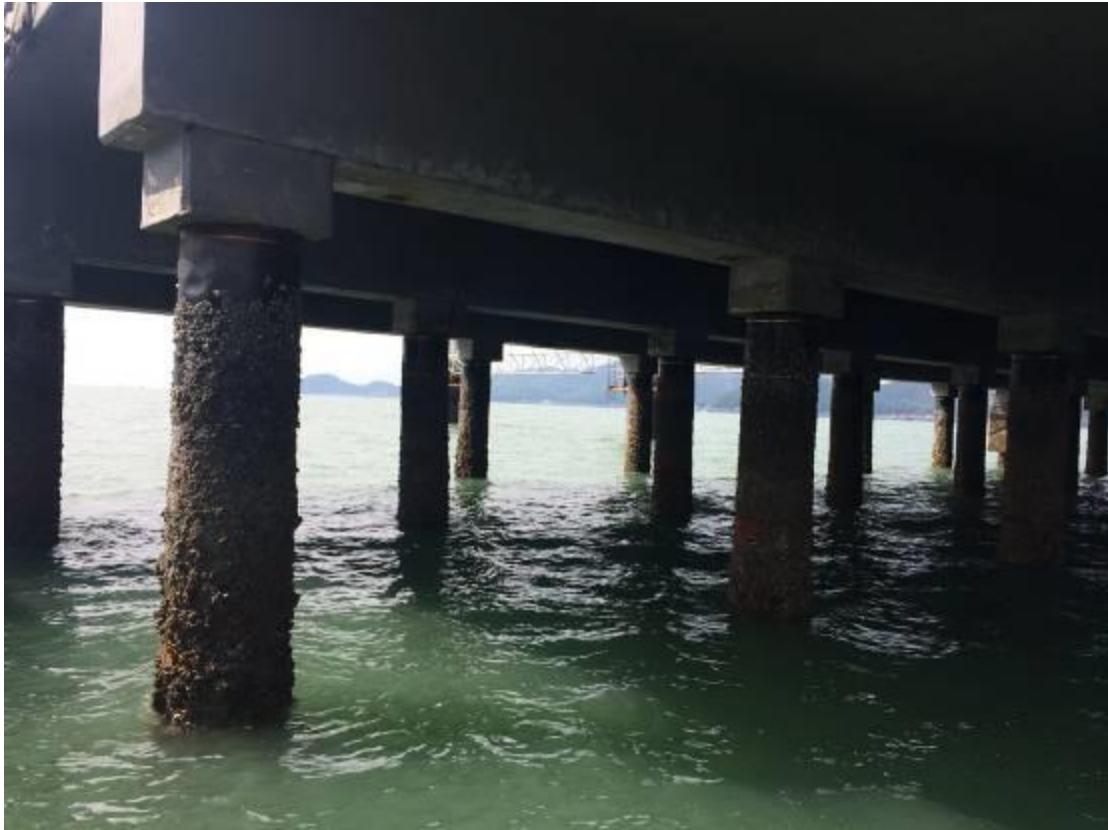
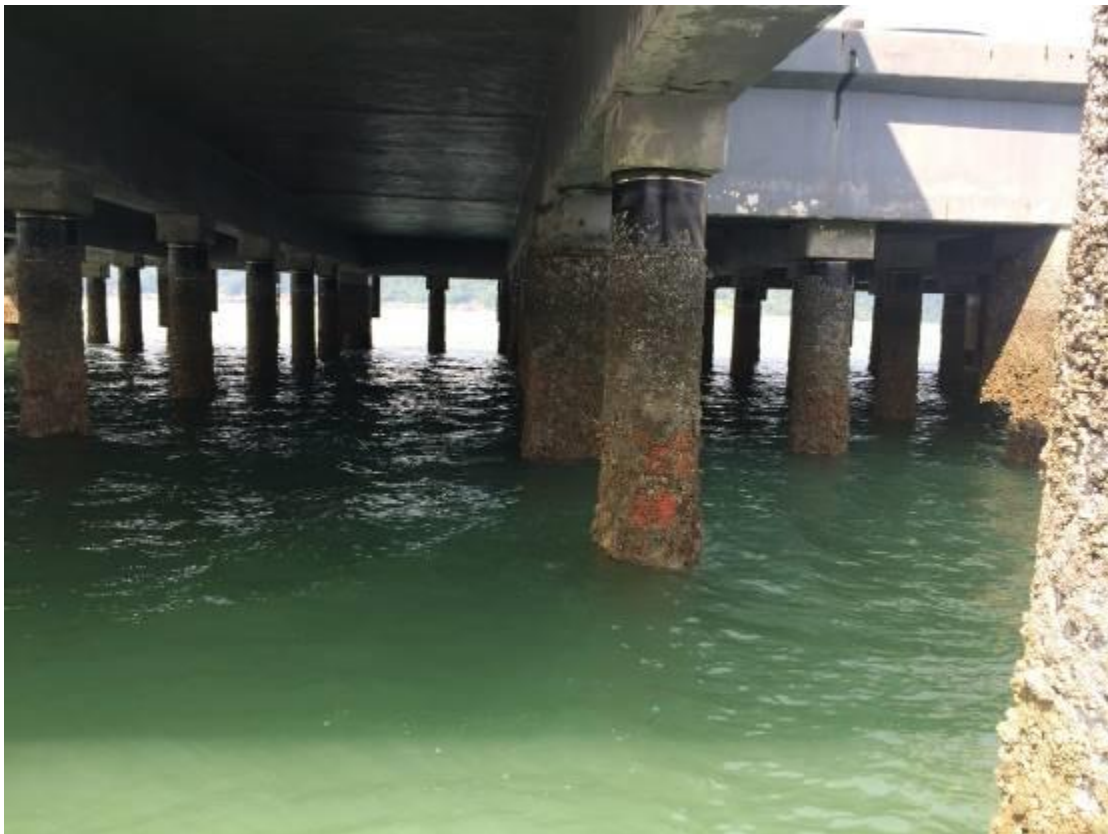
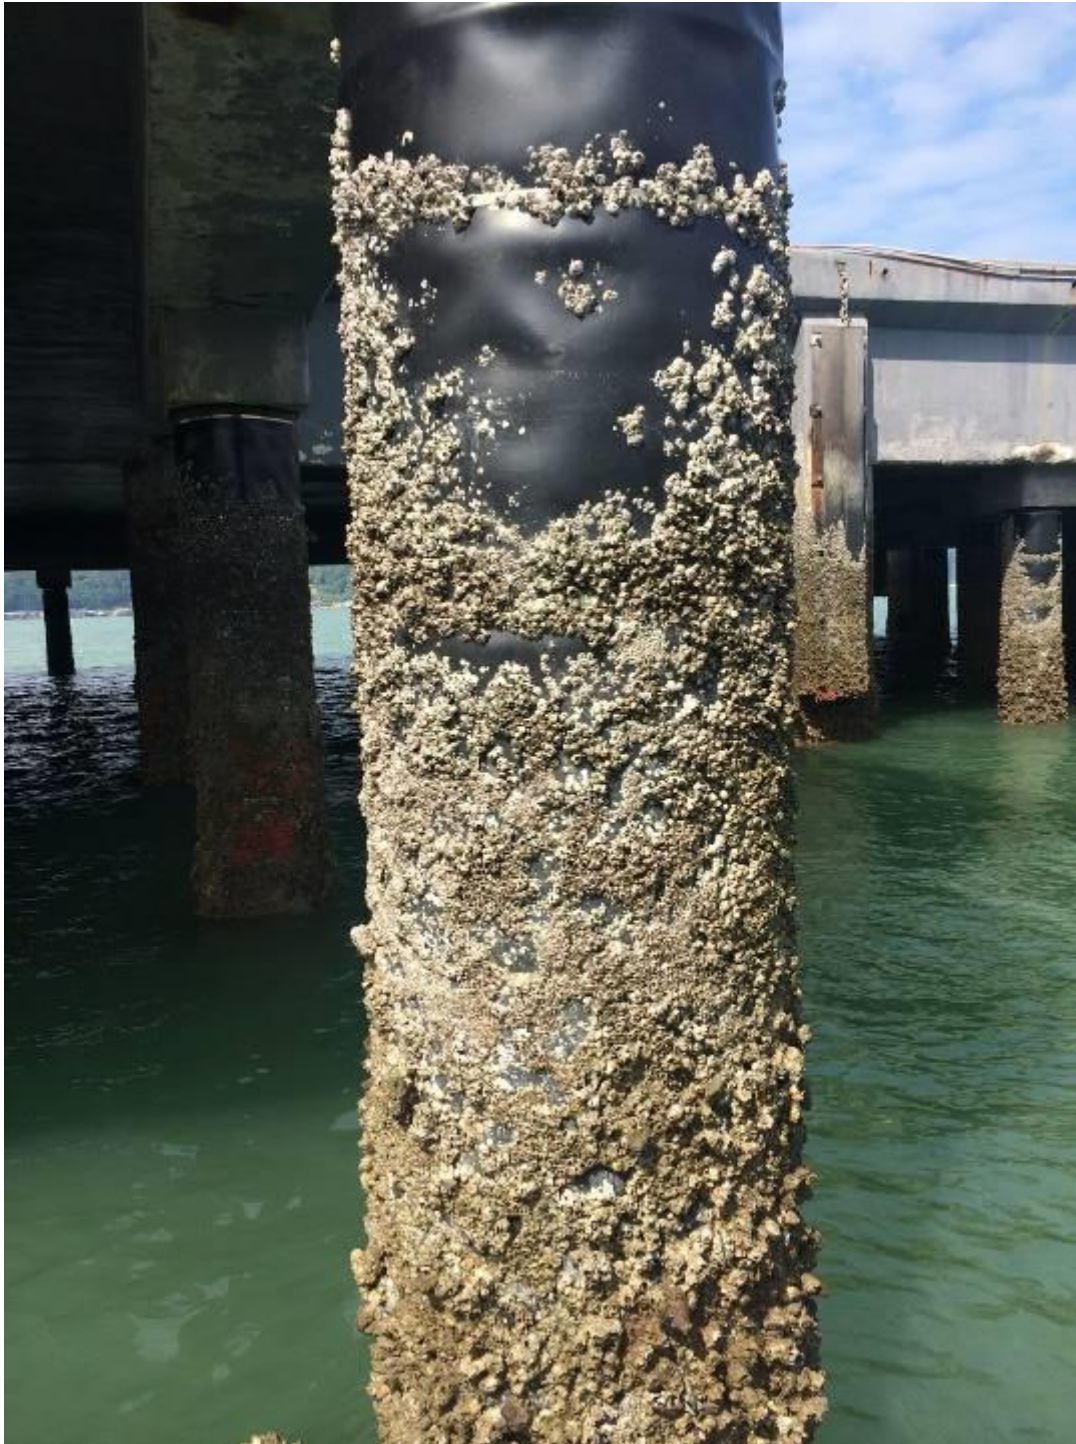
- a. The SS316L straps are holding up well.
- b. No straps were detected missing.
- c. Surface corrosion on straps appeared to be normal/minimal, not discolored from surface rust from the silver appearance seen through the barnacles.
- d. If any straps had failed, the jackets would have opened up and eventually pulled off due to wave action.
- e. Jackets did not appear to have "slid" down the piling, indicating a good banding and installation work

- a. The HDPE jackets appeared deformed. The deformation of the HDPE is normal for M1 jackets which do not have tension or hoop stress on the jacket. The hoop stress is provided through the straps.
- b. With the straps providing the hoop stress in the HDPE jackets, it results in yielding or movement of the HDPE under the banding with the degree of movement according to the wave action experienced at the site
- c. The HDPE jacket appeared to be holding up to some impact issues. There are no visible evidence that something has hit the HDPE and gone through; with no holes detected.

3. The STACwrap
 - a. The condition and the performance of this corrosion protection layer could not be assessed from the pictures.
4. Barnacles growth
 - a. Substantial amount of barnacles have build up on the SPLASHpro system.
 - b. Generally, the barnacles will attach itself to the jackets and not puncture through it.
 - c. From the pictures, it is not visible on the extent or impact the barnacles growth has at the overlap of the HDPE jacket.

4. To assess the complete performance of the SPLASHpro M1-80 system against corrosion, a complete site investigation is necessary.
 - a. Identify one of few piles to represent the whole installation conditions taking into consideration the jackets exposure to sun radiation, wave and flotsam impact and others.
