JETI PELURU, TLDM, LUMUT, PERAK, MALAYSIA -
(Armory jetty, Royal Malaysian Navy, Lumut, Perak, Malaysia)

REPORT ON CONDITION OF SPLASHPRO M1-80 SYSTEM BASED ON SITE INSPECTION

- Client** : TLDM (Royal Malaysian Navy), Lumut, Perak /
JKR, Cawangan Pangkalan Udara Dan Maritim
- Contractor** : Akid Merah Sdn Bhd /
CLM Construction & Trading Sdn Bhd
- Description** : The jetty comprises 105 steel piles.
There are 30 nos. 480mm diameter and 75 nos. 630mm diameter
The splash zone height is 4000mm. Total protected area is 724 sq.m
- Installation** : February to March 2007
- Material used** : SPLASHpro M1-80 System comprising
STACprime UW, STACfill, STACwrap (150mm & 300mm),
STACguard, SS317L band (12.5mm / 0.76 mm), SS 316 Buckle
- Manufactured by** : Central Products LLC, USA /CP Coatings Sdn Bhd
- Supplied through** : STAC System Sdn Bhd
- Inspection Date** : 6th March 2015

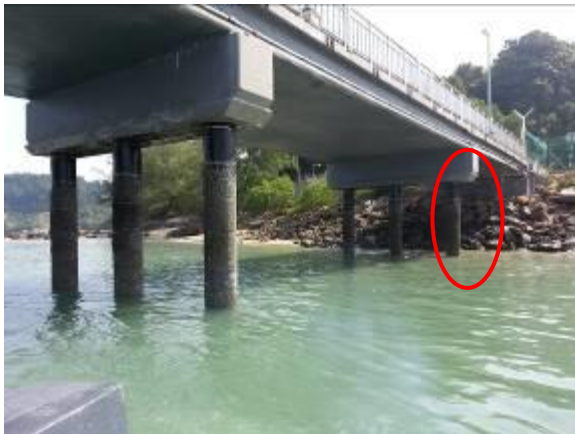
Photo 15: View of Selected Pile

1. From the discussion with the client, the trestle pile closest to the shoreline was selected for detailed inspection.
2. The pile was selected as it was possible to access to it without the use of a pontoon, which is necessary for work to be carried out around the pile when the tide is at the lowest at 11am on the inspection day.
3. One of SS317L was removed and a height of 350mm height of jacket was cut off to inspect the jacket and the STACwrap.

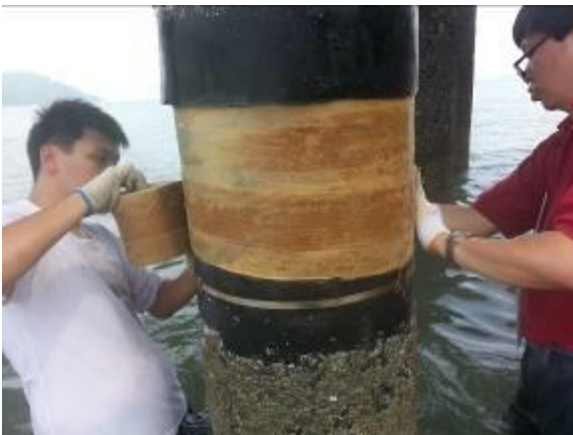
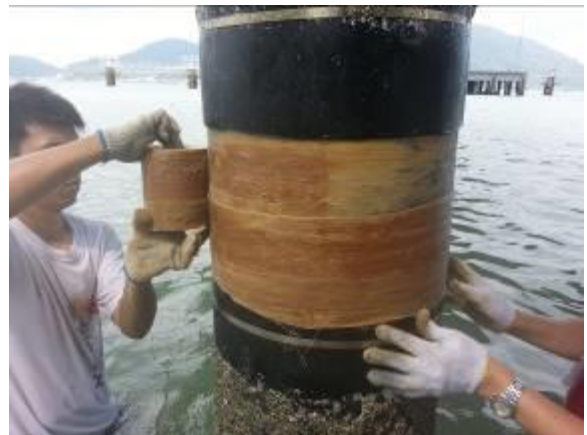
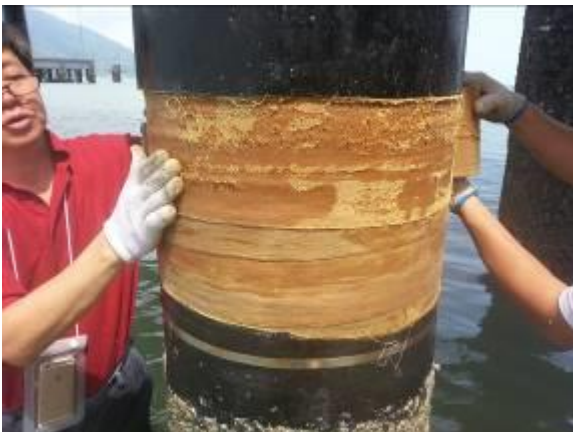
Photo 36: Apply 2 layer STACwrap

1. After completion of the inspection, the STACwrap of the removed section is replaced by a layer of STACwrap.
2. Thereafter, a new 2 layers of STACwrap is applied on over the entire removed jacket area.
3. A section of 500mm height of jacket is installed over the cut section with 2 straps of SS317L installed on the top and bottom edge.

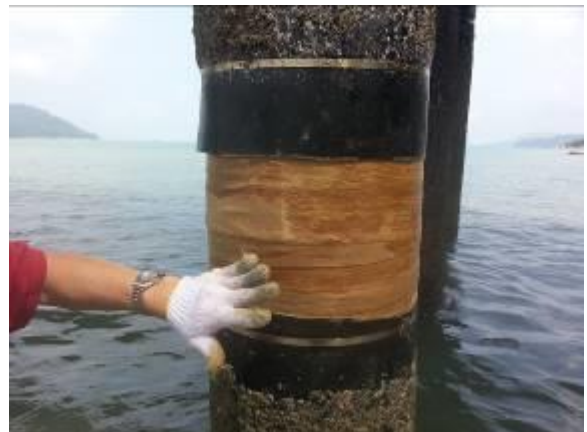
Photo 39: Complete 2 layer STACwrap

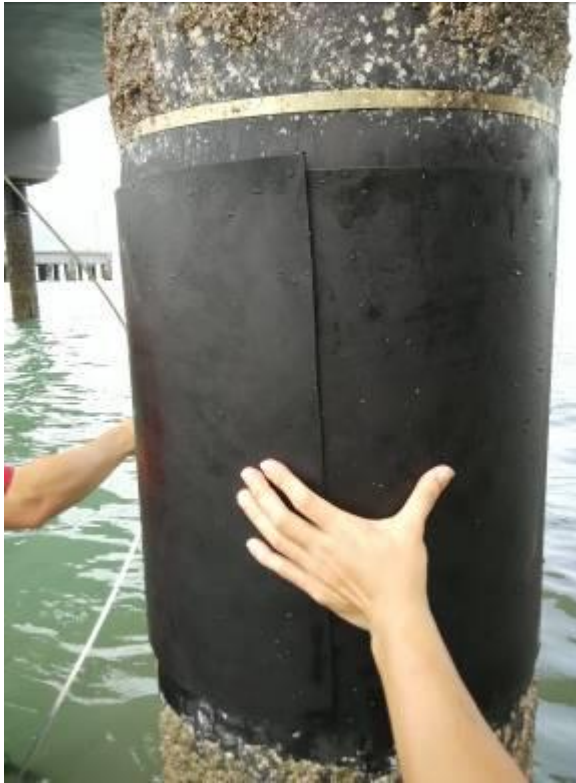
Photo 40: New Section of Jacket

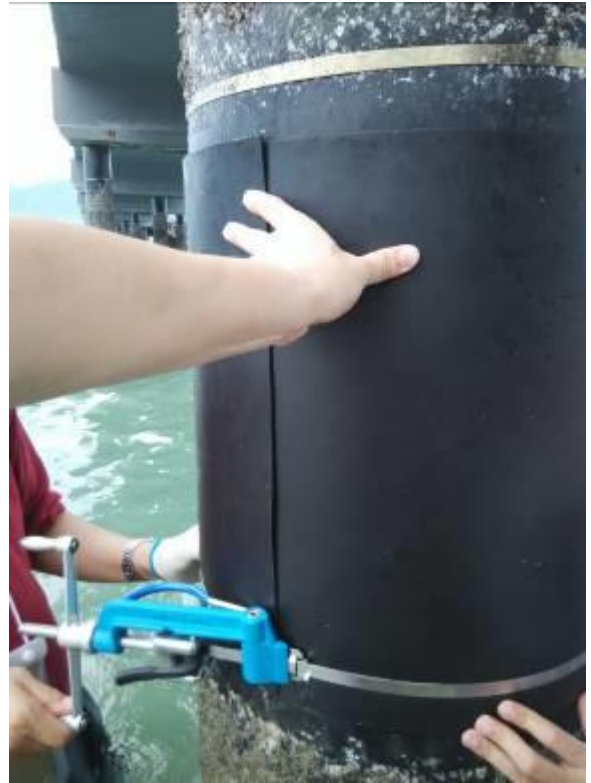
Photo 41: Install Bottom SS317L band

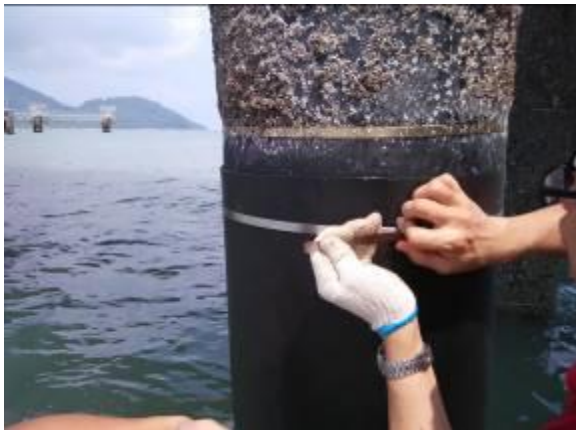
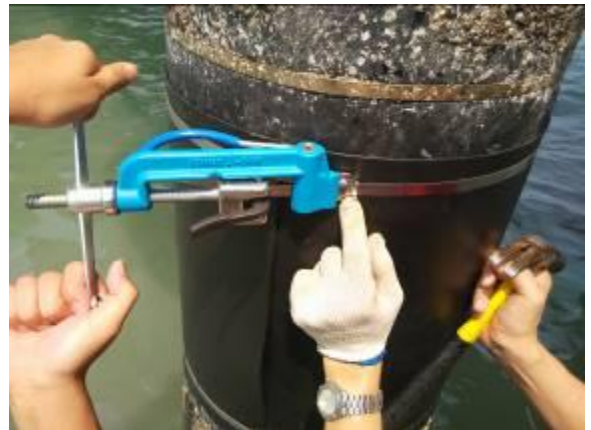
Photo 42: Install Top SS317L band

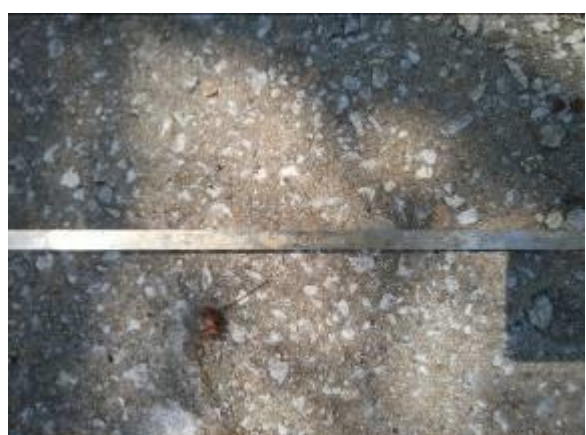
Photo 50: The removed SS317L bands

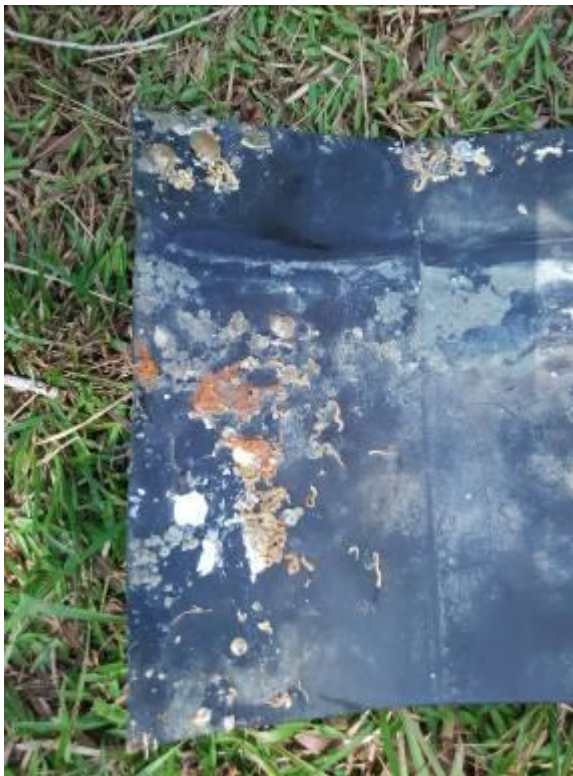
Photo 53: Sample of HDPE Jacket
