JETI PELURU, TLDM, LUMUT, PERAK, MALAYSIA -
(Armory jetty, Royal Malaysian Navy, Lumut, Perak, Malaysia)

REPORT ON CONDITION OF SPLASHPRO M1-80 SYSTEM BASED ON SITE INSPECTION

- Client** : TLDM (Royal Malaysian Navy), Lumut, Perak /
JKR, Cawangan Pangkalan Udara Dan Maritim
- Contractor** : Akid Merah Sdn Bhd /
CLM Construction & Trading Sdn Bhd
- Description** : The jetty comprises 105 steel piles.
There are 30 nos. 480mm diameter and 75 nos. 630mm diameter
The splash zone height is 4000mm. Total protected area is 724 sq.m
- Installation** : February to March 2007
- Material used** : SPLASHpro M1-80 System comprising
STACprime UW, STACfill, STACwrap (150mm & 300mm),
STACguard, SS317L band (12.5mm / 0.76 mm), SS 316 Buckle
- Manufactured by** : Central Products LLC, USA /CP Coatings Sdn Bhd
- Supplied through** : STAC System Sdn Bhd
- Inspection Date** : 6th March 2015

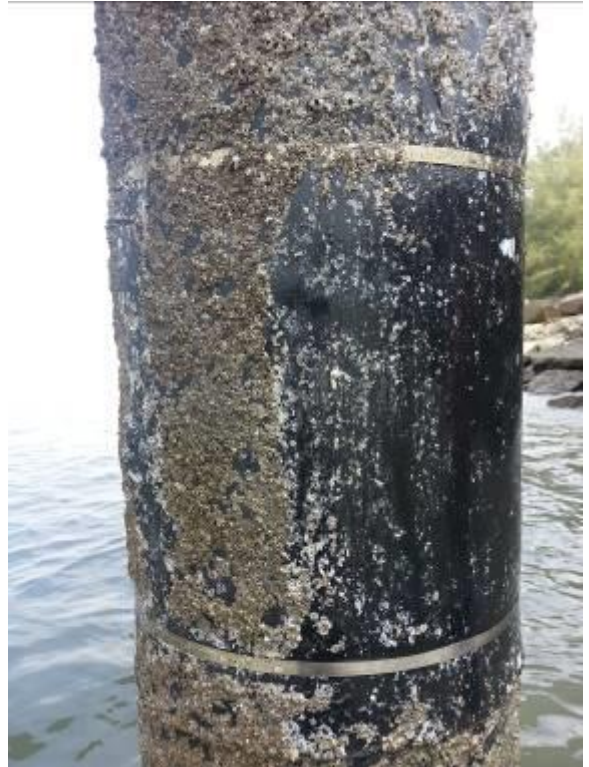
Photo 18: Removal of Barnacle

1. The barnacles could be removed with hand tools. There was no penetration of the barnacle into the HDPE jacket.
2. The barnacles grew into the overlap of the HDPE sheet, but not beyond the overlap.
3. Mud and water were found into the overlap and onto the STACwrap. Mud was observed on the STACwrap.
4. The STACwrap was seen to be in very original condition and no drying up was evident.

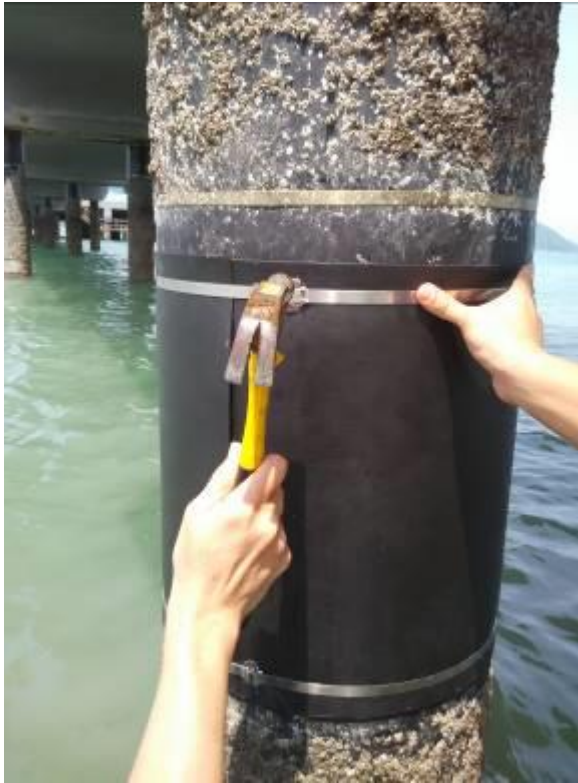
Photo 44: Secure Buckle

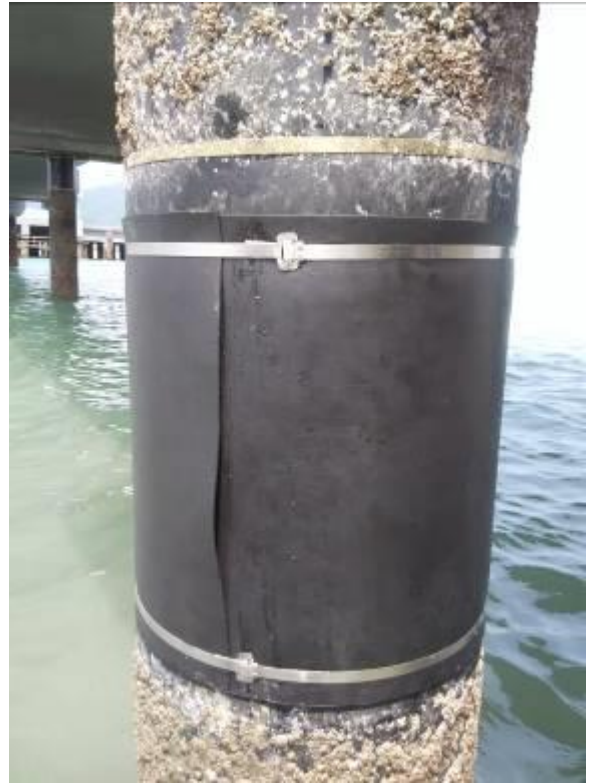
Photo 45: Completed Jacket

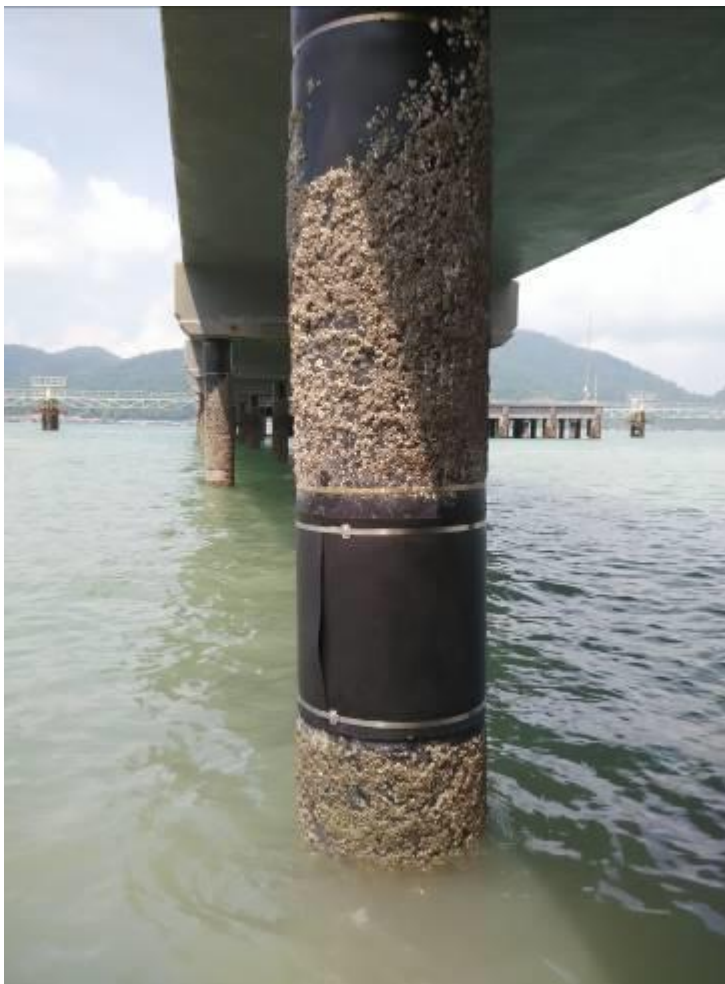
Photo 46: Completed Reinstallation

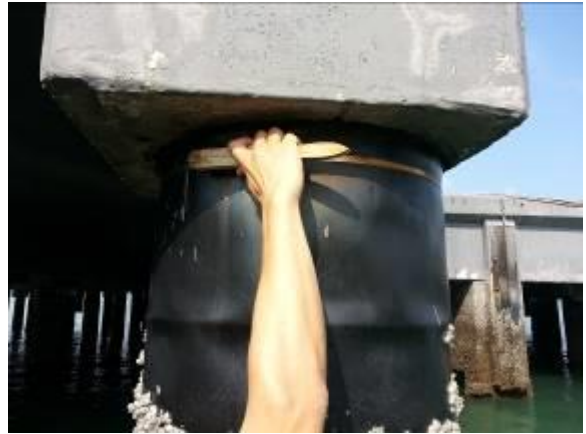
1. The SS317L bands were seen to have stains.
2. Hand brush was used to brush of the stains as well as the barnacle growth.
3. It is observed that these were sticking to the surface as the bands were still shining after cleaning.

Photo 48: Wiring Brushing

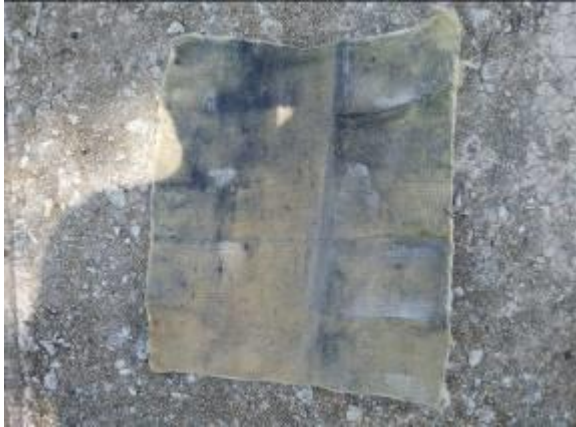
Photo 51: Sample of STACwrap

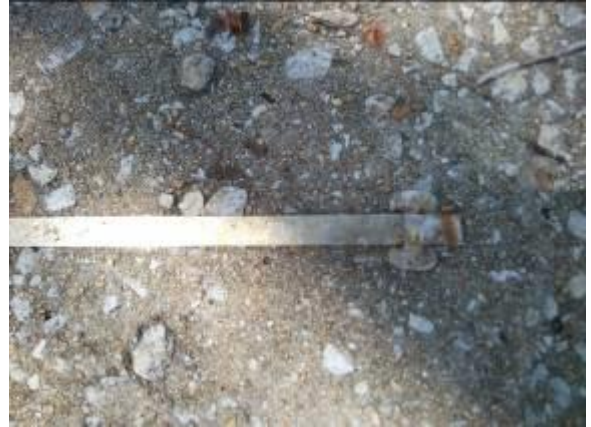
Photo 52: SS317L band and buckle
